Detecting Nascent Pipeline Leaks

Rick Schrynemeeckers

The Problem - Pipeline Leaks

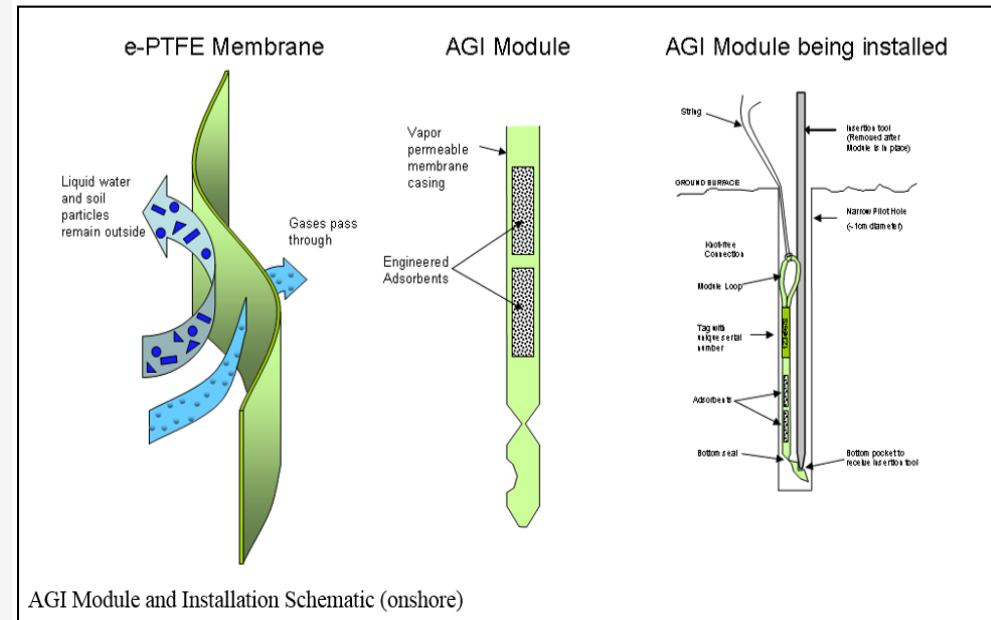
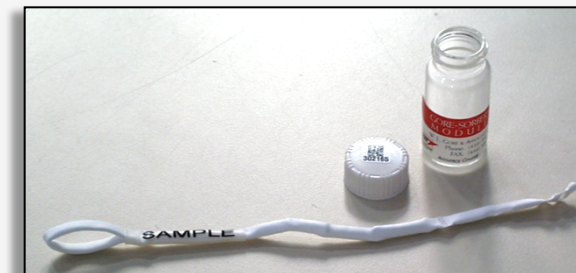
AGI achieves this by using a **patented** passive sorber – [services cannot be duplicated](#).

Hydrocarbon vapors pass through the membrane and concentrate on the polymers within.

This results in a 1,000-fold lower, parts per billion (ppb), detection of hydrocarbons.

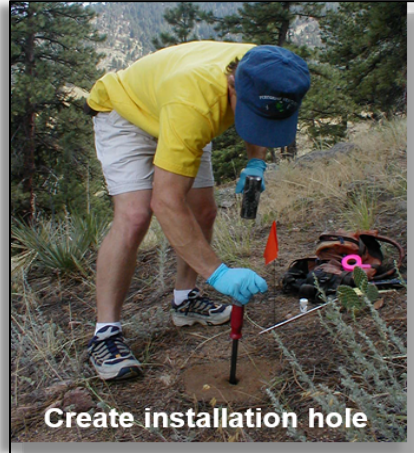
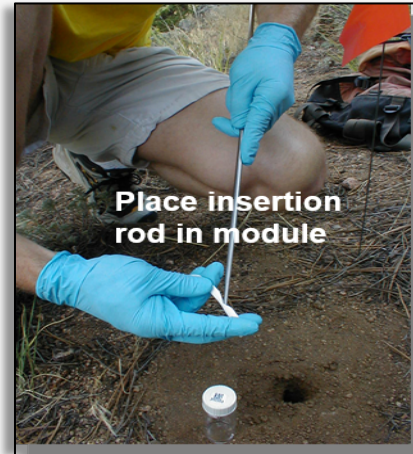
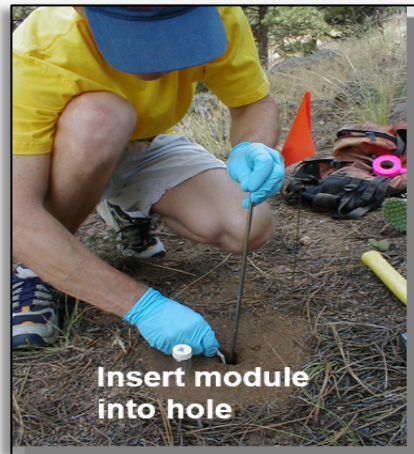
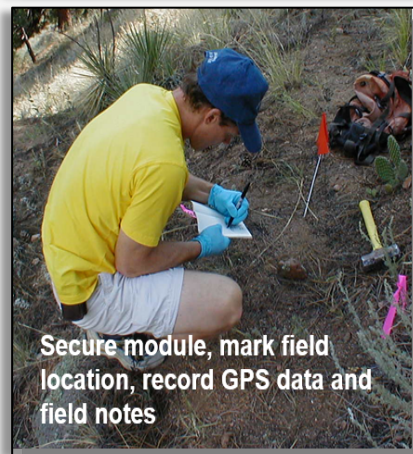
The AGI modules are typically deployed just below the surface along the pipeline.

The field person drills a 1" diameter hole to a depth of approximately 3 feet for each module, as seen on the right.

The module is then inserted into the hole. Once completed the hole is collapsed to cover the module.

Modules are typically retrieved within 2 – 4 days.

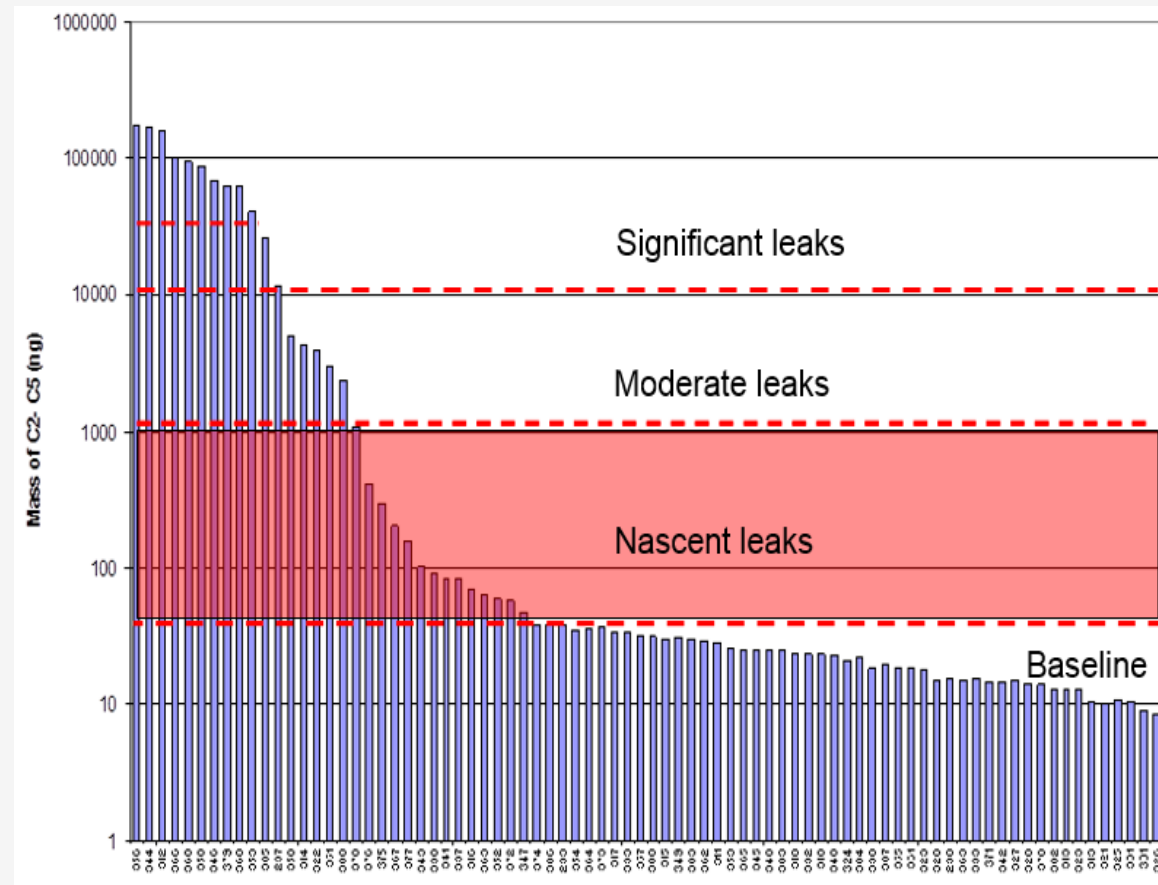
Four Major Divisions in the Data Set

The AGI method detected compounds from C_2 – C_5 and plotted them on a log scale from highest to lowest.

The data indicated 12 samples above the 10,000 ng level, quickly identifying 12 significant leak points along the pipeline.

The data also identified 6 moderate leaks between 1,000 – 10,000 ng.

The data identified 13 possible nascent leaks between 80 – 1,000 ng along the pipeline, that would not be detectable by other methods.

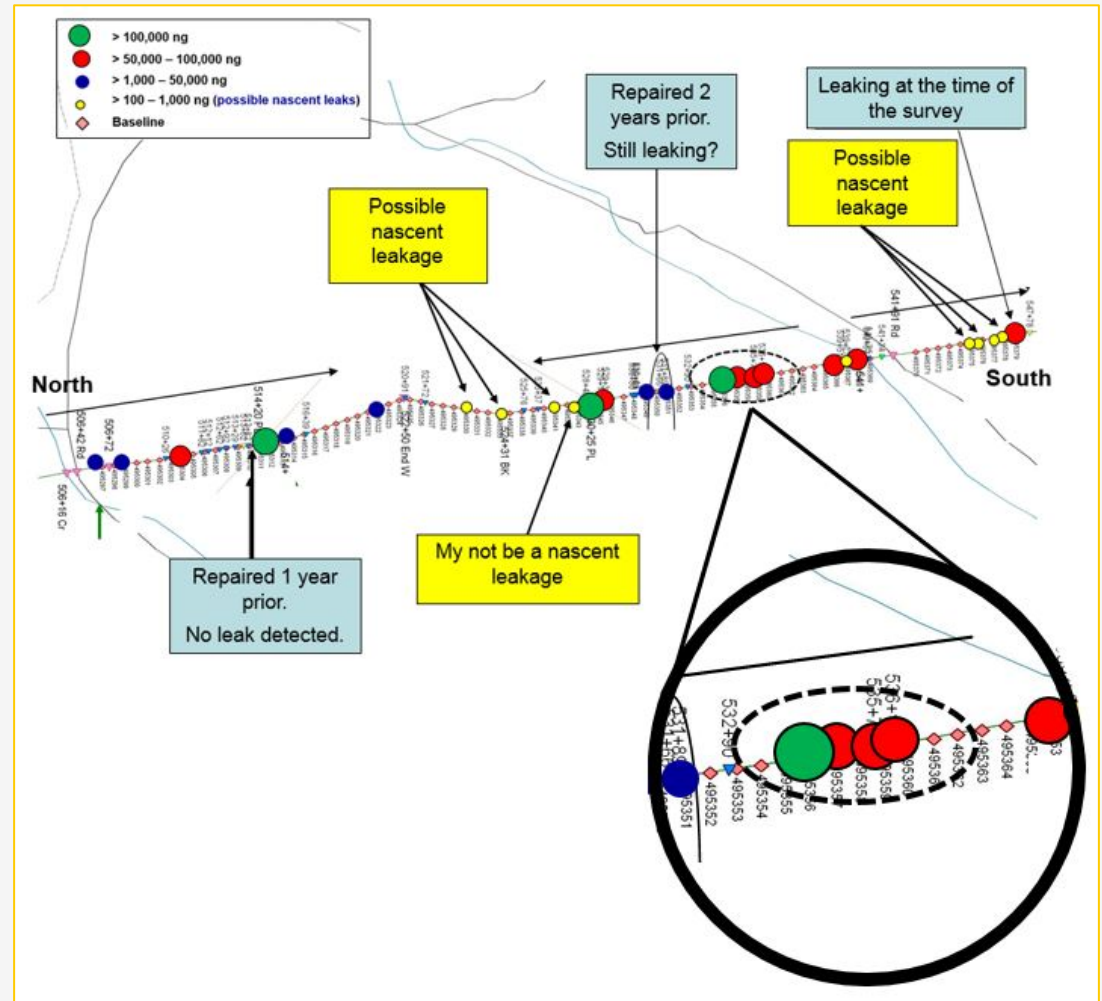
200 ft of Pipe with Substantial Leakage

On the right the natural gas intensities (i.e. the sum of $C_2 - C_5$) are plotted along the pipeline map.

As noted in the legend, the larger the dot the greater the natural gas intensity.

The most critical area of the pipeline may be the black dashed ellipse with the green dot with three red dots adjacent to it.

This indicates a 200 ft section of pipeline with the most substantial leakage along the pipeline.

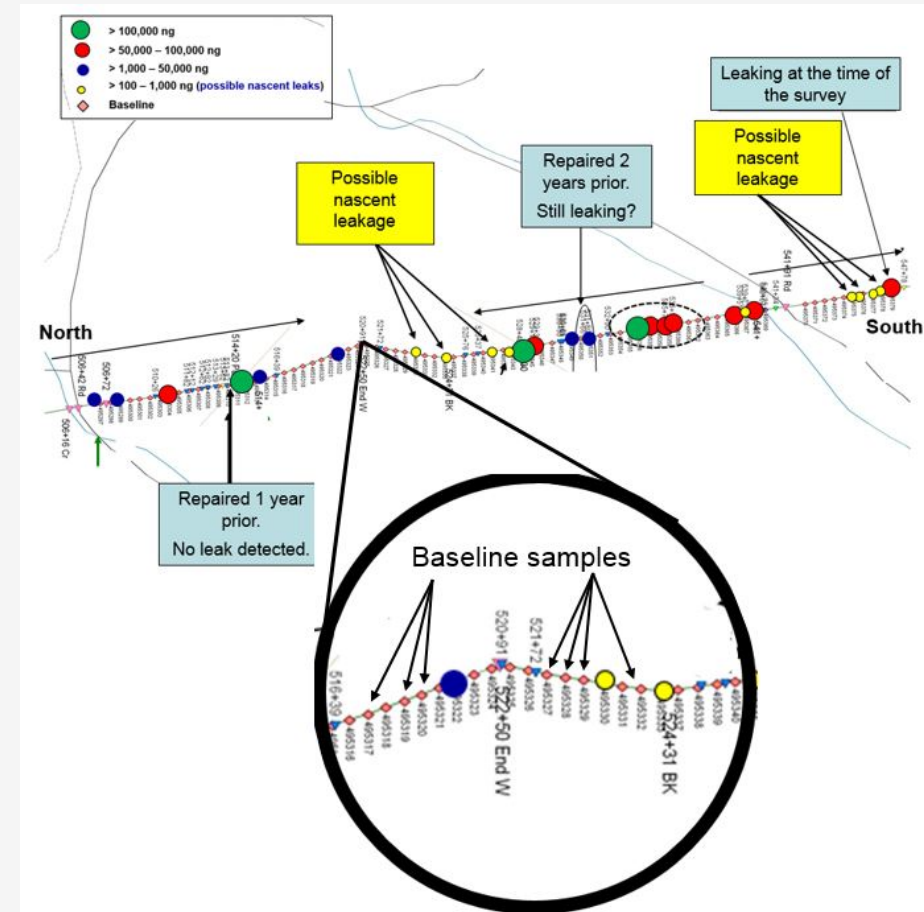
Documenting Intact Sections of Pipe

The extreme sensitivity of the method provides the ability to derive statistically based background concentrations for *in situ* organics.

The baseline samples are noted with a pink diamond along the pipeline.

This capability provides the ability to easily monitor changes over time and provides great baseline monitoring for regulators.
